NATIONAL BUREAU OF STANDARDS REPORT

10 017

Examination of
M513/M514 FUSE SLEEVES

To
Harry Diamond Laboratories

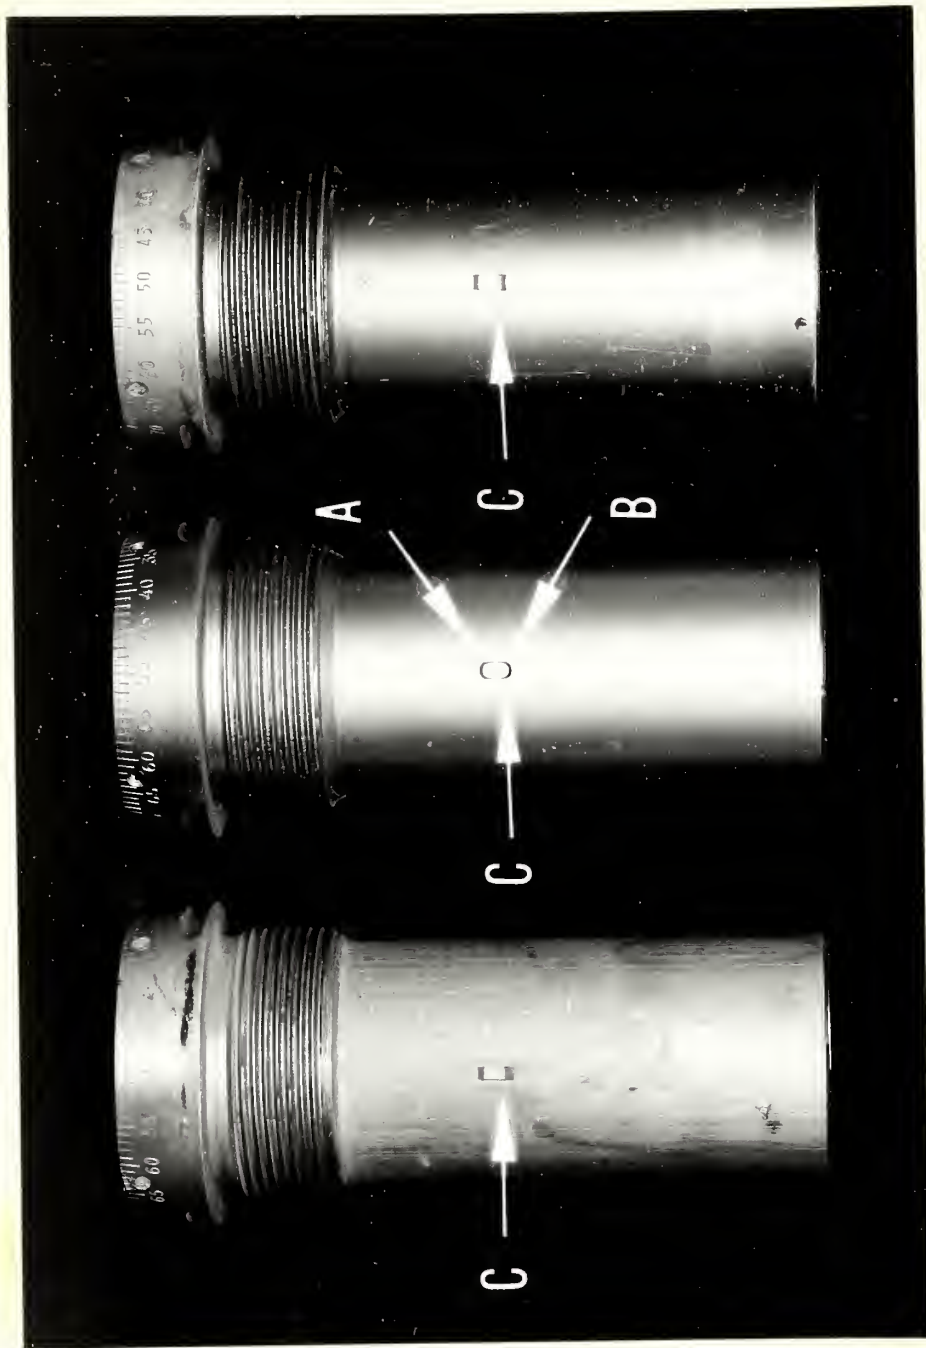
In figure 1, 16 of 33 fuse sleeves of type N fracture during tension testing occurred through the area marked by arrow (B), whereas in the other 17 N's fracture occurred at the position indicated by arrow (A). The failure at these two different areas indicated by arrows (B) and (A) in figure 1, could be attributed to the fact that underside of the semi-perforation, figure 4, did not have as sharp a radii as the top of the semi-perforations. The radii that existed at the top of N, figure 4, were apparently equal. Therefore, if cracks were present on the underside of the semi-perforation type N, the fracture would occur through the

Figure 1. Fuse sleeves in the as received condition. Sleeve on left is type Δ HP, in the middle, type N, and on the right, type ZW. The arrows (C) indicate the item, the semi-perforation, which was investigated on each of the fuse sleeves submitted. Arrow (A) indicates the area through which 53 fuse sleeves, type Δ HP, N and NB, failed during tensile testing. Arrow (B) indicates the area through which 16 of 33 type N fuse sleeves failed during tensile tests.

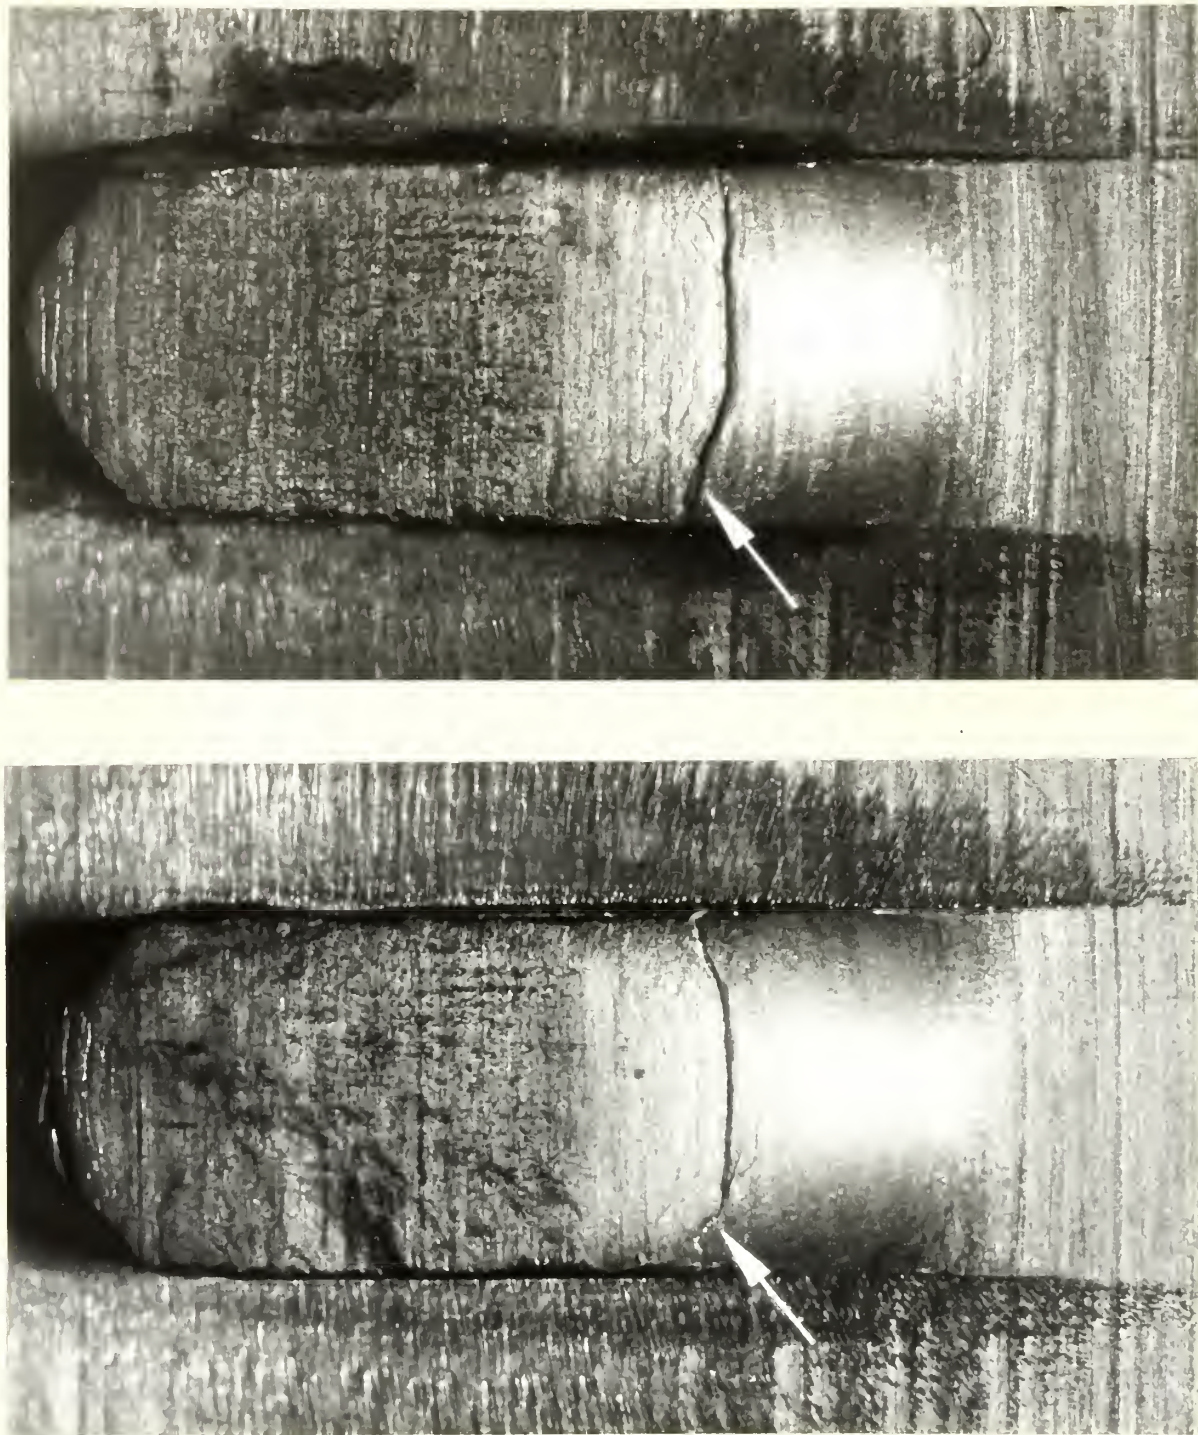
Metallographic Examination: Fuse sleeves 24 to 32 were given a metallographic examination. The sleeves were cut to reveal sections through the semi-perforations. Cracks, as indicated by the arrows in figures 2 and 3, were observed on the underside of the semi-perforations. In figure 3, the crack appears to have opened more after firing. The fuse sleeves were then sectioned longitudinally through the center of the semi-perforation. Photomicrographs of the sectioned semi-perforations are shown in figures 4 to 8. In figure 4, cracks as indicated by arrows (A), were observed on the underside of the semi-perforations in both the fired and unfired conditions. In figures 5 and 6, cracks, as indicated by arrow (A), were observed on the underside of the fuse sleeves where a sharp radius is present. However, in figure 7, the more generous radii as shown by arrows (A) and (B) in the type ZW semi-perforation appear to have been produced by the manufacturers' processing. Cracks were not found in this fuse sleeve.

Figure 2. Photograph of underside of semi-perforation type Δ HP. Arrow indicates crack location. Unetched, X 20.

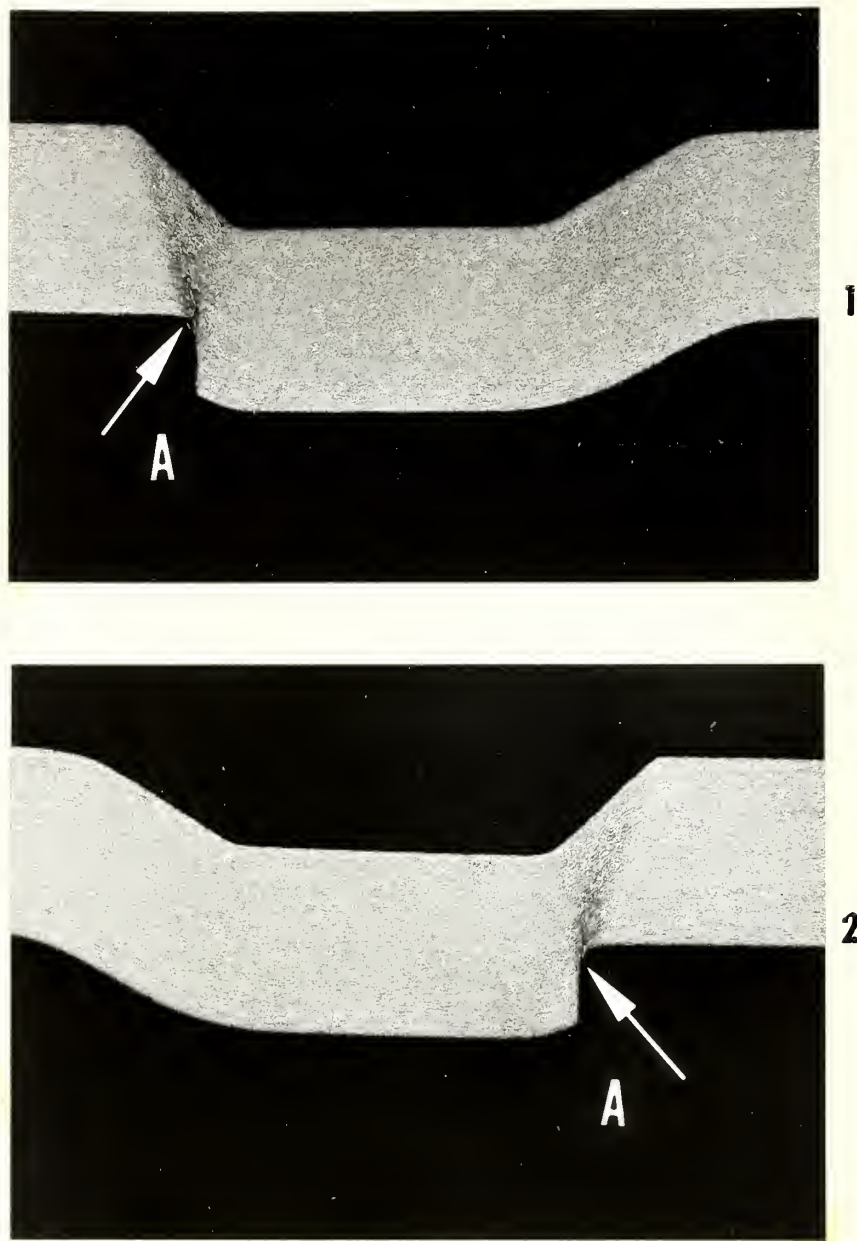
In the metallographic examination of fuse sleeves 24, 25, 26, and 27 (AHP's) and 32 (NB), cracks were observed, figures 5 and 6, only at the sharp radii on the underside of the semi-perforations. However, in the fuse sleeves, 28 and 29 (N's), which were metallographically examined, figure 4, the sharp radii existed at the top of the semi-perforation. The areas of sharp radii in type N were crack free, but cracks were observed on the underside of the semi-perforation on the smooth radii indicated by arrows (A) in figure 4.

Figure 4. Longitudinal sections of fuse sleeves type N, not tensile tested. Photograph (1) is of the fired condition, and (2) of the unfired condition. Arrows (A) indicate location of cracks observed on the underside of the fuse sleeves. Arrows (B) and (C) are locations of sharp radius. Sixteen type N fuse sleeves failed through area (C) and seventeen failed through area (B) during tensile tests. Etched, Keller's, X 12,

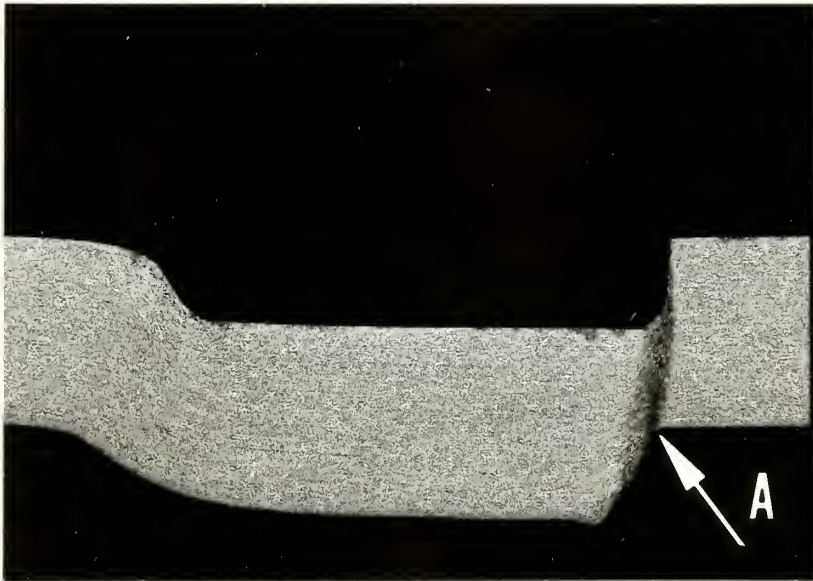
sharp radius adjacent to the larger of the pre-existing cracks. In fuse sleeves type Δ HP and NB, which were tested in tension, fracture occurred only through the area indicated by the arrow (A) figures 1, 5 and 6. This area of fracture initiation has sharp radii and apparently had initial cracks present such as those shown in figures 5 and 6, by arrow (A). The presence of a sharp radius and a crack are stress concentrators, and during tensile tests, failure would tend to occur through this area of the semi-perforation. Due to these stress concentrators, the breaking loads obtained on types Δ HP, NB, and N should be lower than those of a fuse sleeve which did not have a sharp radius and a crack present, such as in type ZW, figure 7.

Figure 5. Longitudinal sections of fuse sleeve type Δ HP, not tensile tested. Photograph (1) is of the fired condition, and (2) of the unfired condition. Arrow (A) indicates area through which failure occurred during tensile tests, and area of a crack and sharp radius. Etched, Keller's, X 12.

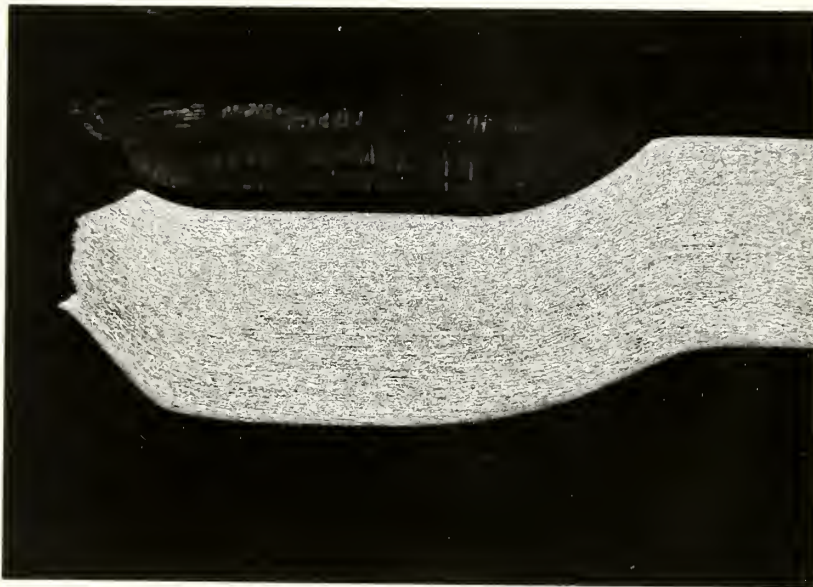
Cracks were found on the underside of some semi-perforations in both unfired and fired fuse sleeves. Firing appeared to have an effect of opening the cracks somewhat. No cracks were found in sleeves marked ZW and it was ascertained that the semi-perforations in these fuses had more generous radii and hence had been deformed less severely than the others. The design and manufacture of the semi-perforation in type ZW is therefore considered superior to the others examined.

Figure 7. Longitudinal sections of fuse sleeve type ZW, not tensile tested. Photograph (1) is of the fired condition and (2) of the unfired condition. Arrows (A) and (B) indicate areas of smooth radius. Arrow (A) also indicates area through which fracture occurred during tensile tests. Etched, Keller's, X 12.
